## Removal of Rock Art Affected by the Raising of the Clanwilliam Dam Wall, Western Cape Province, South Africa: Techniques and Procedures

Jeremy C. Hollmann, Frans Prinsloo, Wouter Fourie & Marko Hutton

To cite this article: Jeremy C. Hollmann, Frans Prinsloo, Wouter Fourie & Marko Hutton (2017) Removal of Rock Art Affected by the Raising of the Clanwilliam Dam Wall, Western Cape Province, South Africa: Techniques and Procedures, *Conservation and Management of Archaeological Sites*, 19:4, 244-268

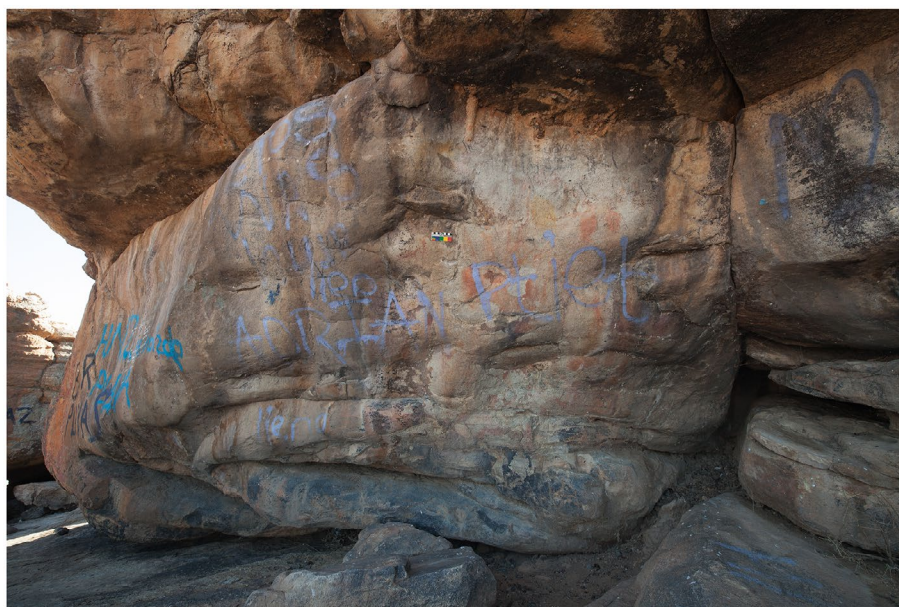
**Figure 3.** Site CDE01, on the edge of the Clanwilliam Dam, had paintings of several fat-tailed sheep that were earmarked for removal but these images could not be located after the site was severely vandalised.

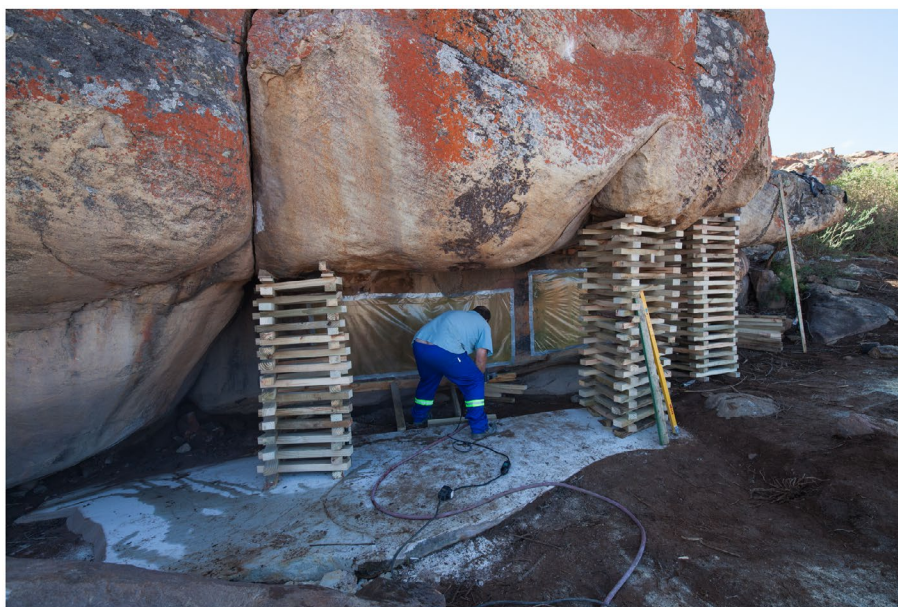
John Parkington, project advisor, expressed concern about the overhang of the shelter collapsing while the removal was in progress. Frans Breytenbach, a geotechnical engineer who was called in, advised that it was safe to proceed, provided props were placed under the overhang. The site engineer had planned to put in steel props but decided on Breytenbach's advice instead to put in wooden packs (Figure 10). Prinsloo also glued two glass devices into angled corners of the overhang. These served as early warning devices – should they crack they would warn of the impending collapse of the overhang.

**Figure 10.** The overhang at Site CDE02 was reinforced with wooden packs to support the rock mass above the paintings.

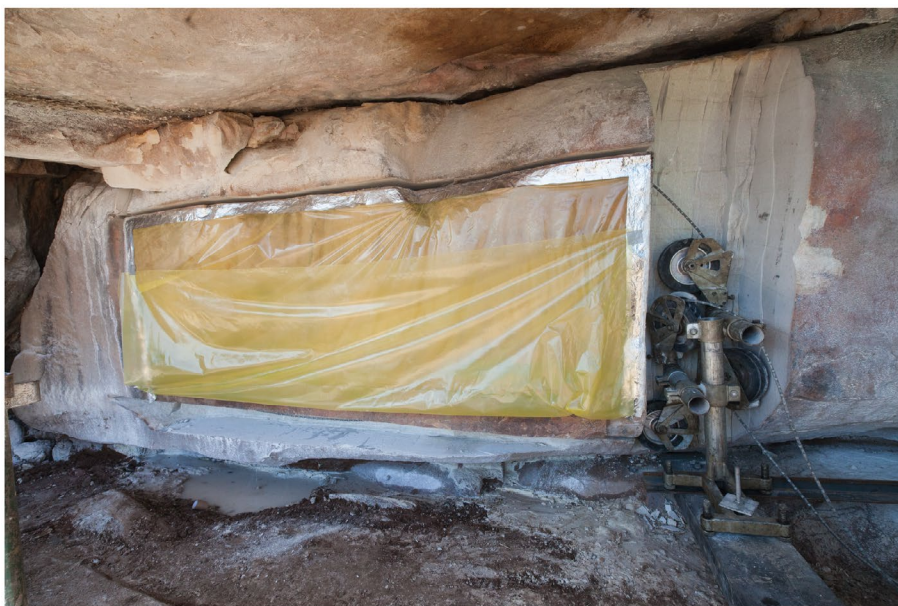
**Figure 14.** The rock art at Site CDE02 was waterproofed with plastic sheeting, aluminium tape and silicone. The pulleys at right are part of the diamond wire saw setup.

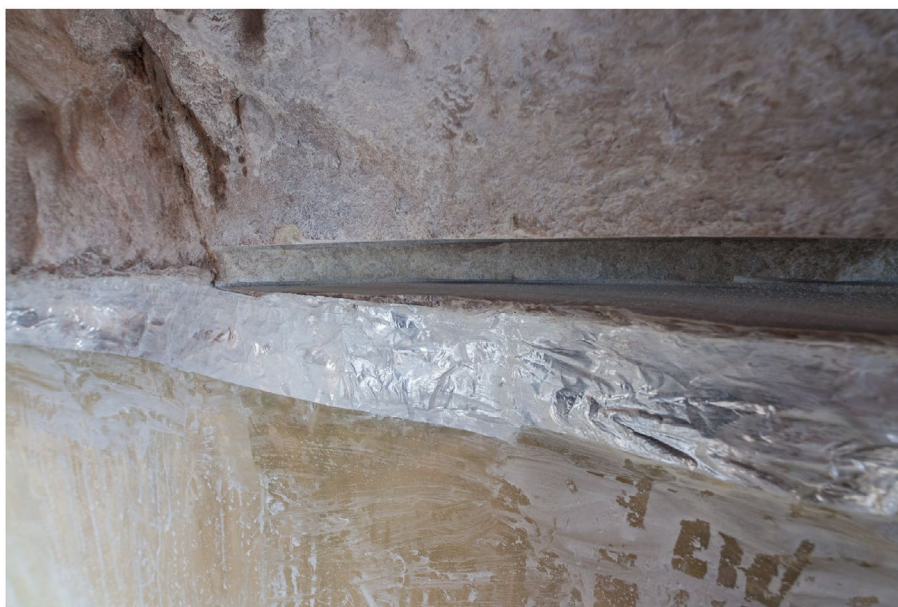
The top cut was next (Figure 15). After 40 min of work the double-bladed cutter cut into the silicone beading and some of the slurry ran over the paintings in a streak about 5 mm wide and 200 mm long. Cutting was stopped immediately and the plastic sheeting that covered the rock art was lifted at the bottom (it had intentionally not been sealed). The slurry was cleaned off with cotton wool poultices. Further cutting was postponed until the following day. The bottom edge of the plastic was drawn away from the rock and weighted with bricks to let air in at the bottom and to dry the rock. Then the damaged beading was repaired with fresh silicone.

**Figure 15.** The top cut along the top of the block at Site CDE02 varied in depth between 150 and 350 mm and was made with a double-bladed rotary cutter that was cooled with water.

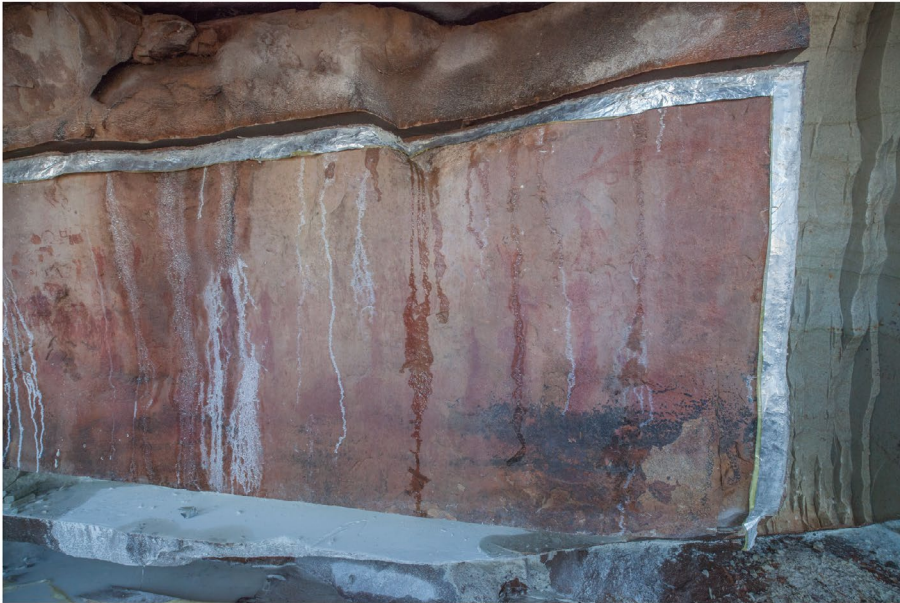
in making the top cut had punctured the plastic. In addition, it could be seen that slurry had leaked through onto the paintings in certain areas along the top edge of the block where the sealed edge had parted. There were now several streaks of slurry over the painted surface

(Figure 16). In order to prevent staining of the rock surface these streaks were cleaned off immediately using cotton wool poultices. The cleaning process took 3 h and 45 min. Then all the plastic and the top tape was removed and replaced with fresh, new plastic and aluminium tape.

**Figure 16.** Breaching of waterproofing caused by a defective silicone seal and the accidental breaching of the plastic. The slurry was immediately removed and there is no permanent damage to the rock art.

A second consequence of using water-cooled cutting techniques was the risk of the waterproofing being accidentally breached. This occurred at CDE02 and to a lesser extent at CDW10. The waterproofing problems at CDE02 were caused by two factors. One was that the silicone seal was not properly applied in certain areas along the top edge; the silicone was not smoothed out to cover the edge of the aluminium tape. The second cause of the breach of the waterproofing was the small holes made in the plastic covering the rock art

by the guide plank that was used to keep the top cut on track. The leakage could have been avoided by using another method to keep the cut straight. These accidental oversights caused no permanent damage to the rock art and may be avoided in any future rock art removal work.

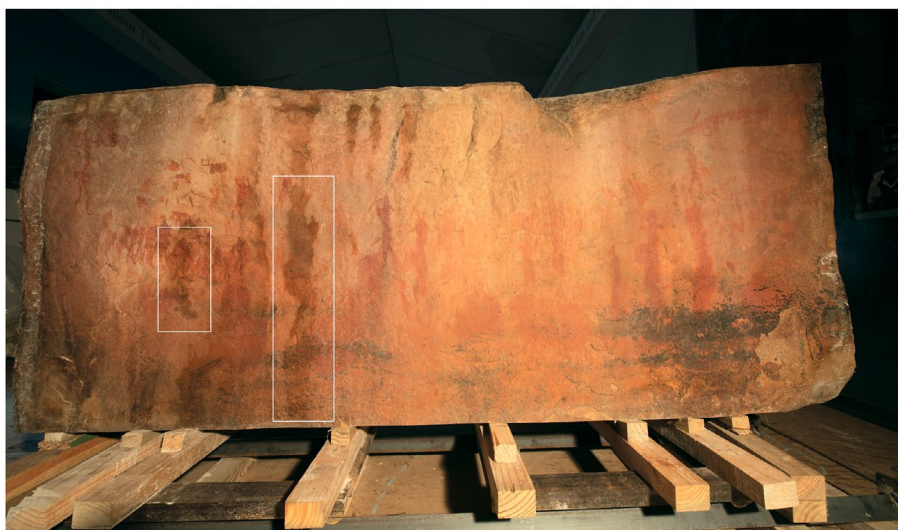
In the aftermath of the removal the rock art specialist became concerned about 'stains' over certain paintings –two streaks each between 100 and 150 mm wide, running down over the rock. What was this substance 'staining' the rock? Were these streaks caused by the leakage along the top edge of the waterproofing? The blower was used for about one and a half hours but this procedure made no visible difference to the streaks.

By comparing these 'stains' with photographs of the accidental slurry staining that occurred during removal it was established that there was no correspondence between the slurry streaks (now removed) and the darker, moist-looking zones. It was concluded that the 'stains' were indicative of moisture (water) within the rock. It had started raining, humidity levels were high and the temperature was low (<20° C) and thus evaporation was not happening very quickly. A lamp was therefore set up in front of the rock in order to facilitate the

evaporation of the moisture-laden rock. The lamp was kept on for the following 21 days. The rock face was regularly monitored to make sure that it was not warm. Within two days the left hand most 'stain' had disappeared and the other streak had begun to slowly diminish,

**Figure 20.** The block from Site CDE02 rests on a platform of rails and planks and is wedged with wooden chocks. The dashed rectangles draw attention to areas of moisture within the block. The left hand area dried out within two days. The area at right continues to dry out.

and it continues to do so. These developments seemed to confirm the hypothesis that the block of rock was moisture laden in places.

The moisture inside the block probably originated from the use of water to cool the cutting equipment. More specifically, the use of water to cool the wire saw when making the back cut – which took almost three hours to complete – might have been the reason why the block absorbed moisture.
