## Removal of Rock Art Affected by the Raising of the Clanwilliam Dam Wall, Western Cape Province, South Africa: Techniques and Procedures

Jeremy C. Hollmann, Frans Prinsloo, Wouter Fourie & Marko Hutton

To cite this article: Jeremy C. Hollmann, Frans Prinsloo, Wouter Fourie & Marko Hutton (2017) Removal of Rock Art Affected by the Raising of the Clanwilliam Dam Wall, Western Cape Province, South Africa: Techniques and Procedures, *Conservation and Management of Archaeological Sites*, 19:4, 244-268

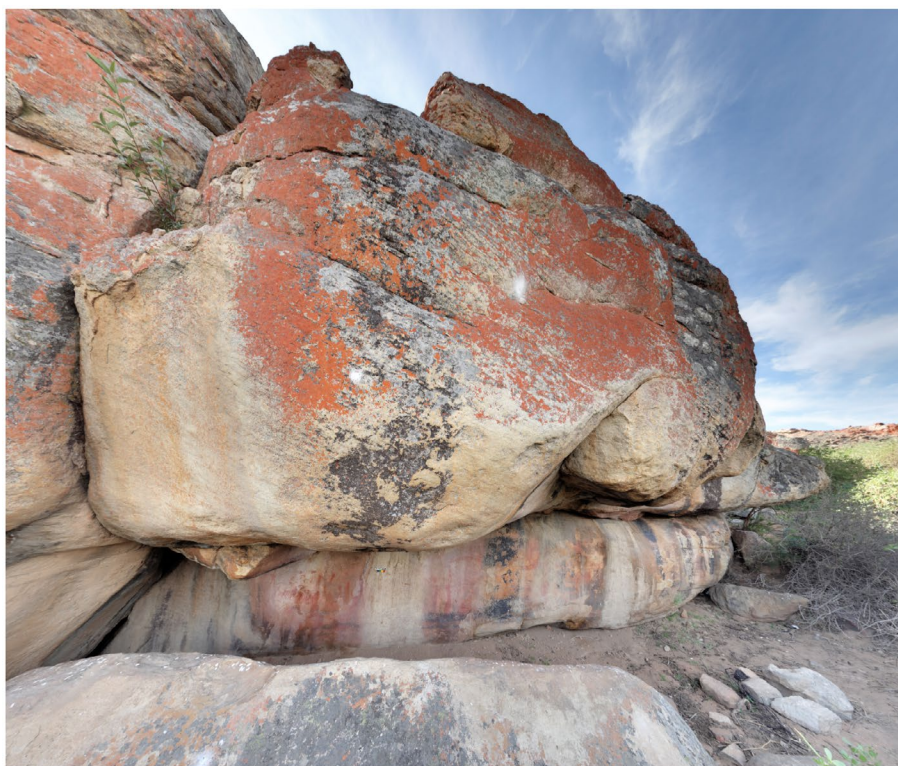
**Figure 7.** An overview of the rock art to be removed from Site CDE02.

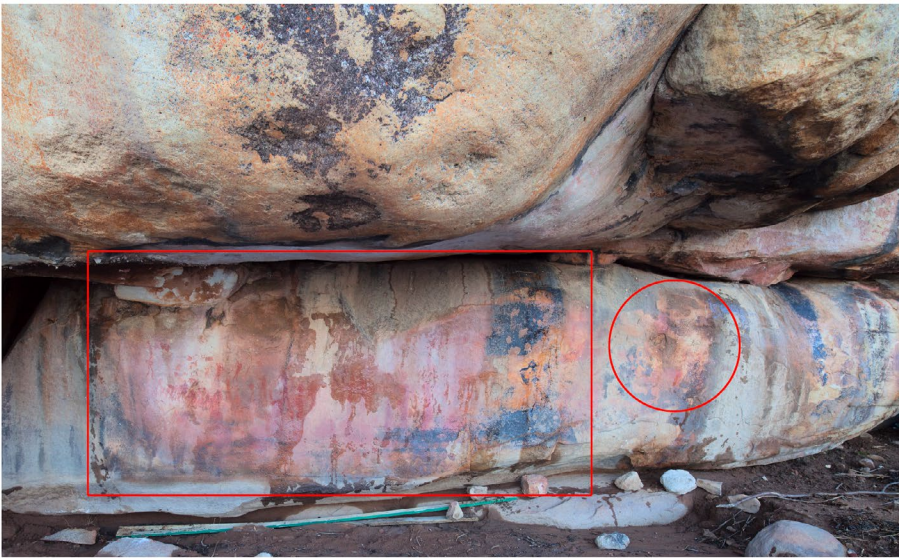
CDE02 comprises rock paintings that are spread out over about 5.8 m. Two wash zones (areas covered with a white salt-like deposit) have divided the painted surface into three areas (A, B and C). Area A has the best-preserved art (Figure 4), followed by Area B (Figure 11). Area C (1.2 m wide and 0.93 m high) is covered with a similar white salt-like deposit and comprises a few weathered images (Figure 12). Restoration work by Rock Art Conservator Steven Bassett in late 2015 removed most of the white deposits between Area A and B. The HIA recommended that, if possible, the 'entire painted surface should be kept intact' (Orton and Hart 2005, 76). The cost and difficulty of a removal of this size was assessed against the heritage value of the rock art in Area C. The project director and rock art specialist finally

**Figure 8.** The entire painted surface at Site CDE02 is over 5 m long. Only the rectangular area at left (Areas A and B) was cut out. Area C was excluded so as to remove a block of rock that was manageable and less likely to fracture.

decided to exclude Area C because of the great size and weight of the block of rock to be removed – 5 m in length and 0.30 m wide. A block this size is not easy to work with and the risks of breaking increase as the size of the rock increases (see Loubser 1994, 445).

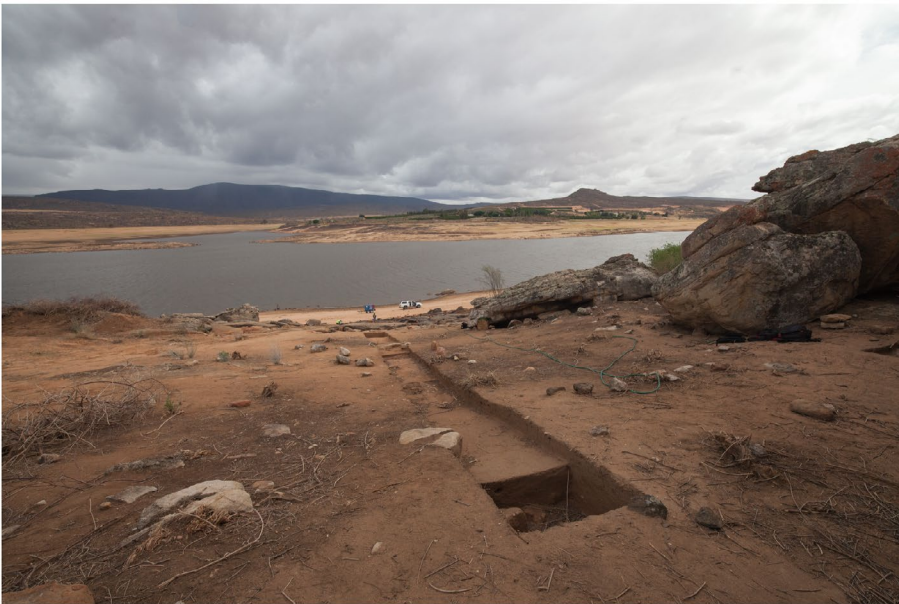
the eastern shore of the Clanwilliam Dam through the grounds of the Clanwilliam Dam Resort (Figure 9). The level of the dam was extremely low at this time and so it was possible for vehicles to be driven along the hard sand on the exposed shore. A track about 10 m long was constructed from the shore of the dam uphill over a low rock terrace in order to get close to the site.

**Figure 9.** View from Site CDE02 down to the Clanwilliam Dam. Access to the site was along the sandy shore of the dam. A transect has been excavated down the slope.

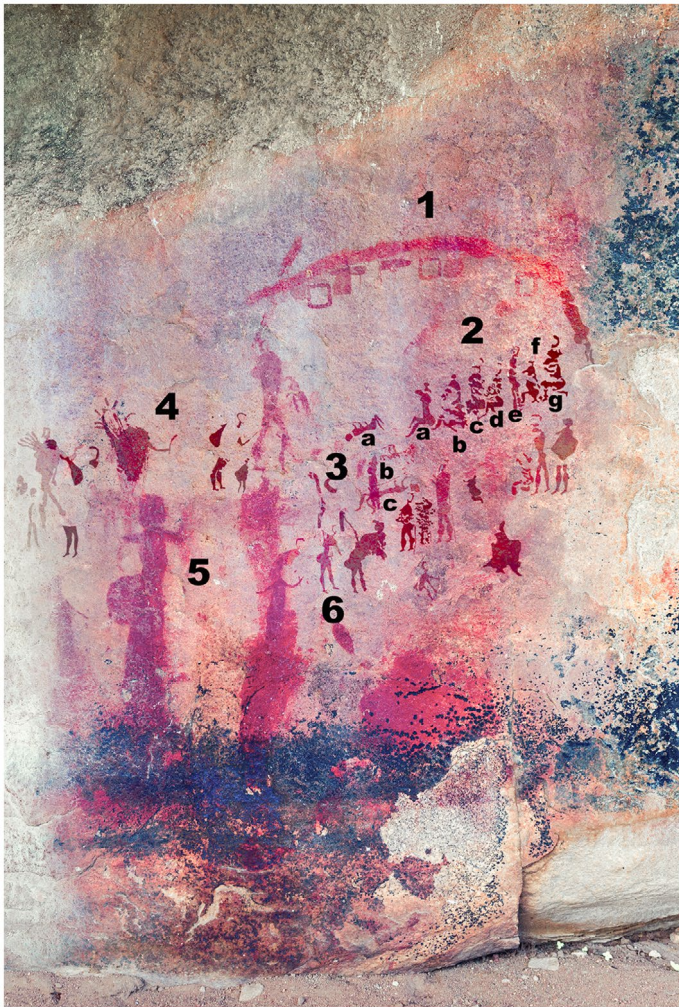
**Figure 11.** Rock paintings at the right hand end of the block that was removed at Site CDE02. Enhanced image with DSTretch and Photoshop.

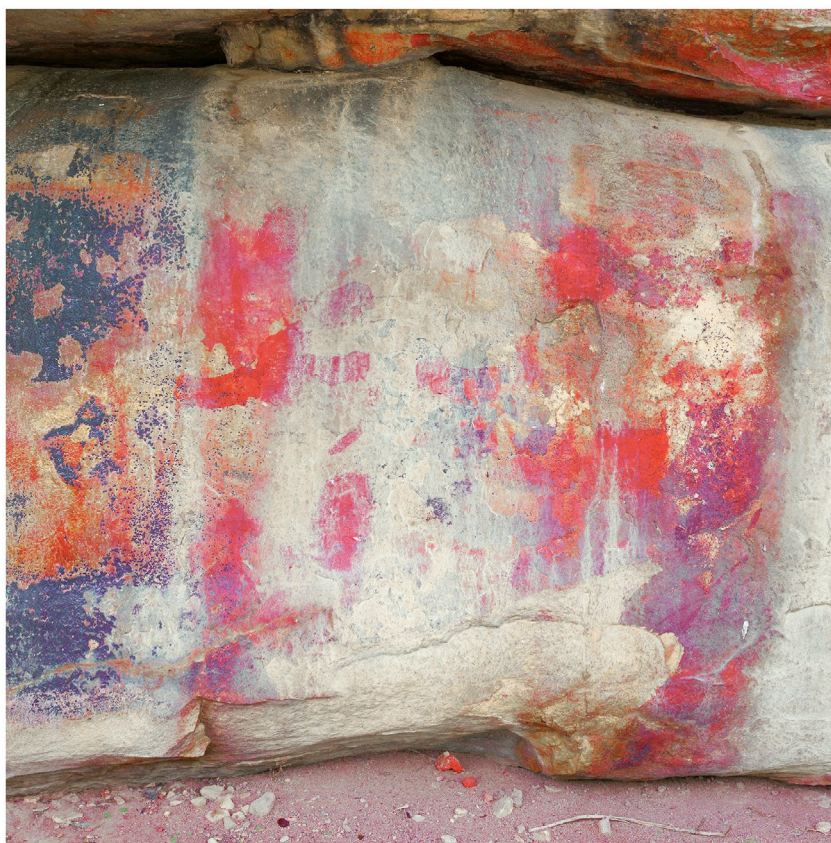
**Figure 12.** Faded images of large antelope at Site CDE02 (Area C). These paintings were not removed. Enhanced image with DSTretch and Photoshop.

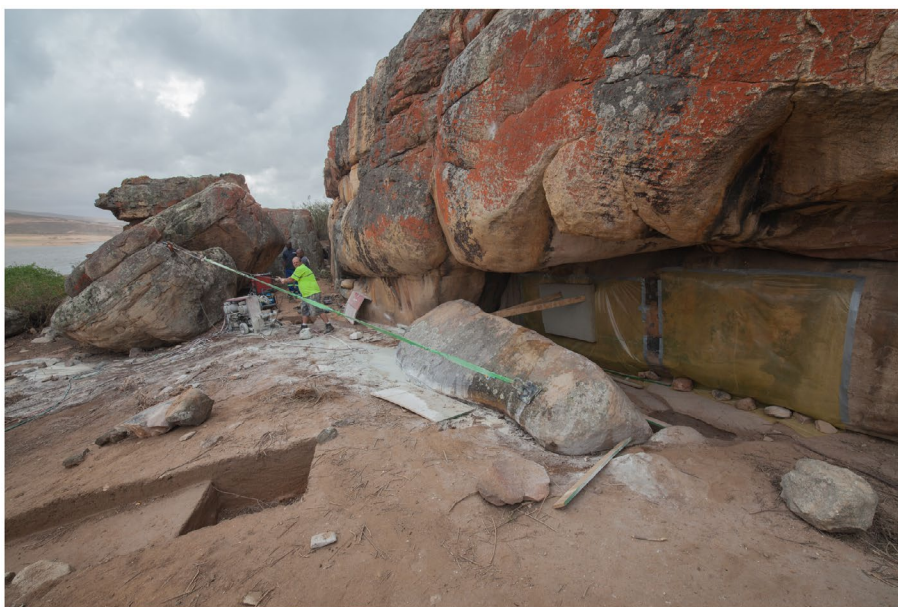
A block of rock protruding from the ceiling of the overhang about 0.2 m thick, 0.76 m long and 0.7 m wide impeded access to the rock art and so it was removed. Thereafter, a large rock in front of the rock art about 8.65 m long and 1.2 m high and weighing approximately 9 to 12 tonnes needed to be shifted to gain free access to the rock art (Figure 13). With these operations completed the team could start to remove the rock art.

**Figure 13.** A 9 to 12 tonne block of rock at Site CDE02 that was in front of the overhang was cut off at ground level and dragged out of the way using a block and tackle.

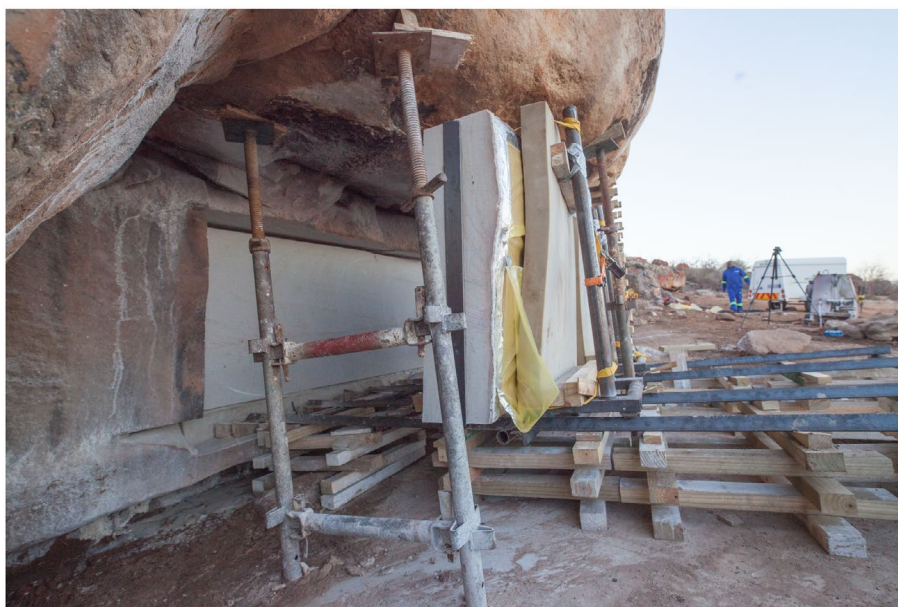
The back cut with the wire saw took 2 h and 50 min. The block was now free of the parent rock (Figure 17).

The block on its cradles was pulled out about 1.3 m and the back of the block inspected. At least five horizontal hairline cracks were visible. The back of the rock was cleaned of the slurry, then dried using a blower. Finally, the strengthening carbon fibre strips were glued onto the back of the block.

**Figure 17.** The block at Site CDE02 has been cut free and has been wheeled from underneath the overhang on a cradle on rails.

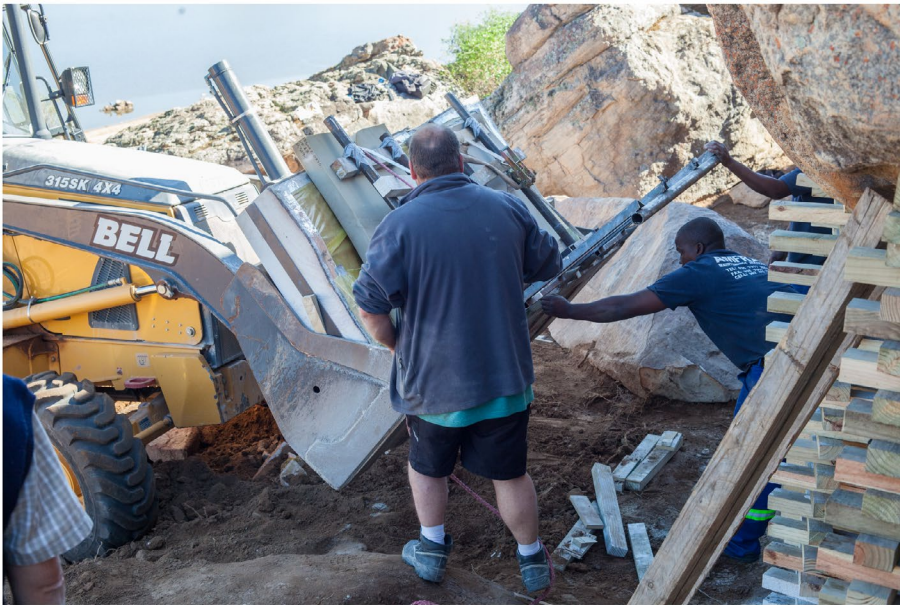
**Figure 18.** The painted block from Site CDE02, still strapped to its cradle and with a short section of rails, is loaded into the carrier bucket of a TLB.

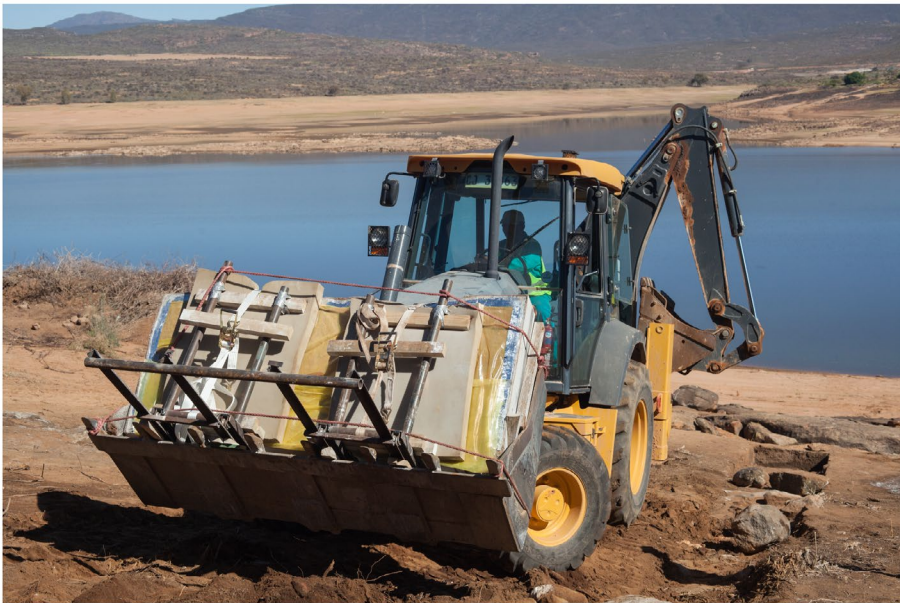
**Figure 19.** The block of rock from Site CDE02 on a TLB loaned by Department of Water and Sanitation on its way to temporary storage in the nearby town of Clanwilliam.

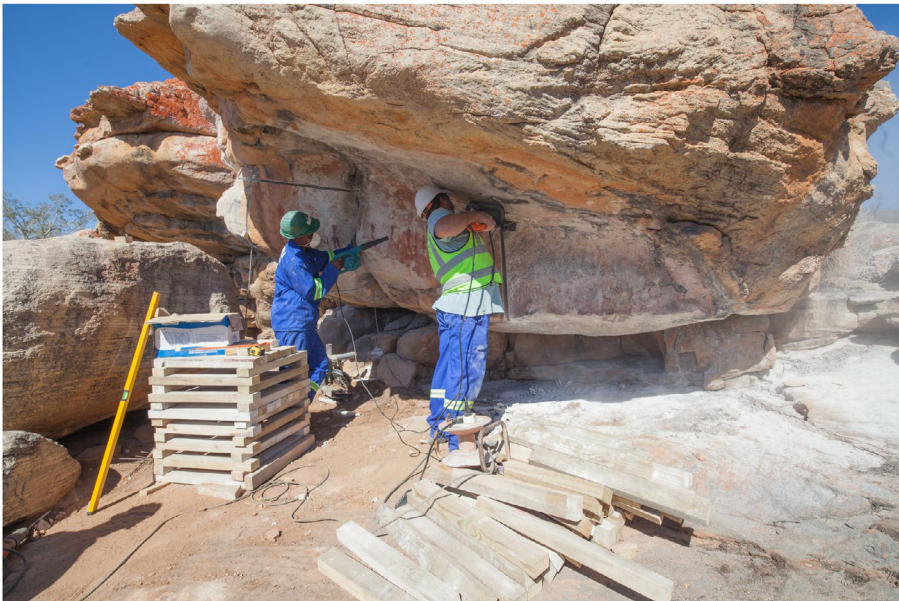
Remains of a bird's mud nest above, but not covering, CDW10 Area C were removed with a penknife blade. The precise locations of the cuts were outlined in pencil. The double-bladed rotary cutter was used to make the cuts required (Figure 21). The cuts were made dry, i.e. without the use of water-cooling. Cutting dry produces a lot of fine dust but it was decided

**Figure 21.** Site CDW10, the second site from which rock art was removed. Guide cuts for the diamond wire saw are being dry cut with the double-bladed rotary cutter. A blower is used while cutting in order to keep dust from settling on the rock art.

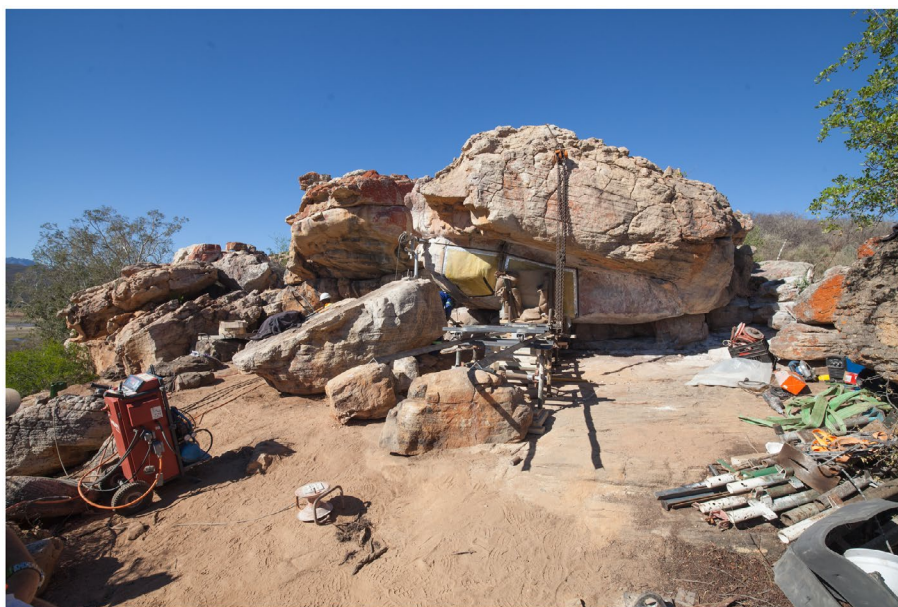
Attention was then focused on setting up the wire saw (Figure 22). The top cut had to be deepened and extended along the top of CDW10 Area B to the left to facilitate the wire cutting. The cut on the right hand side of CDW10 Area C was also deepened. Once the diamond wire saw was in position sand bags filled with sieved soil from the nearby archaeological excavation at CDW11 was packed onto the cradle.

**Figure 22.** The diamond wire saw set up for cutting at Site CDW10. The wire saw is controlled from the console at left.

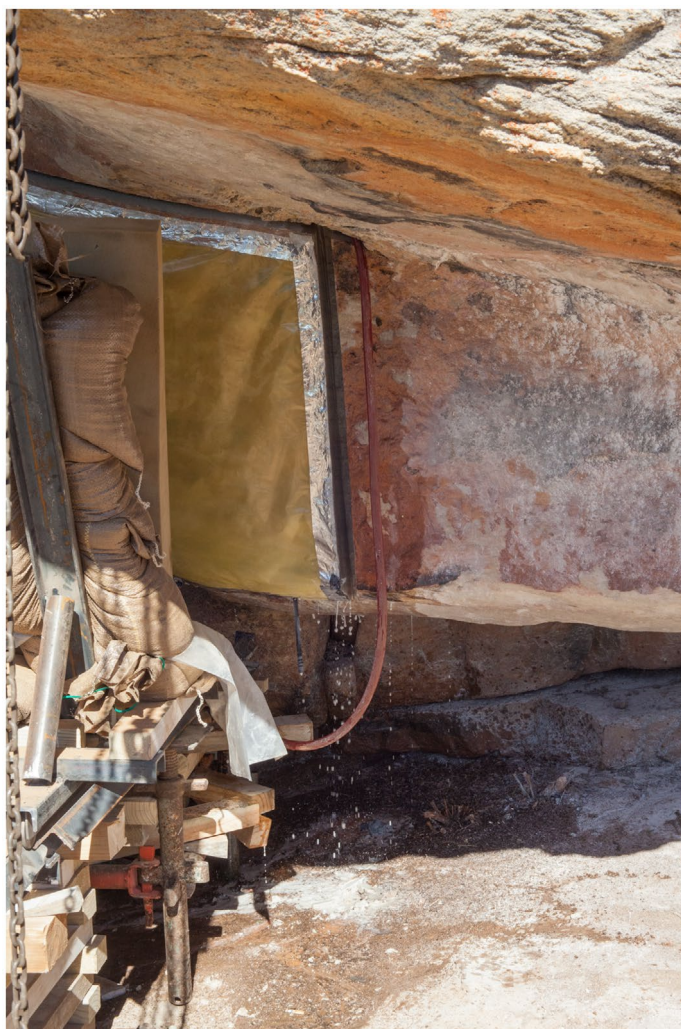
Wire cutting (water-cooled) commenced at 13:30 (Figure 23). The cutting speed was initially 6 m/s and then increased slightly to 7 m/s. The cradle was kept away from the art until the wire cut was firmly established. Then the cradle was pushed closer to the block. An additional anchor point was created. About halfway through the cut it was noticed that the bottom right hand corner waterproofing of CDW10 Area C had been breached by the wire saw. No art was affected, however, and the slurry was promptly removed. At the same time it was also observed that water was pooling on the top edge of the block.

**Figure 23.** Water-cooling the diamond saw at Site CDW10. The red hose is feeding water into the cut that the diamond saw is making. A thin slurry of water and dust drains to the ground.

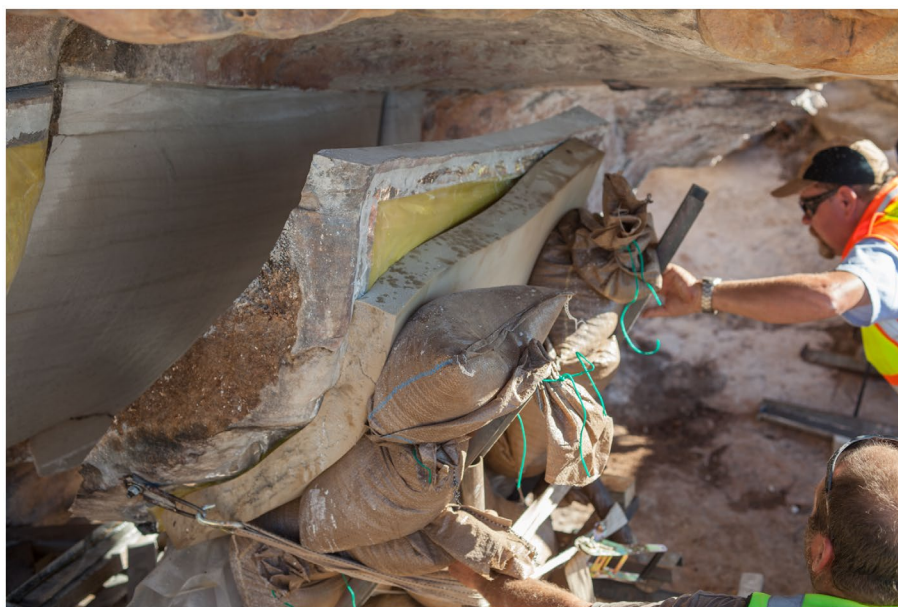
By 15:50 the cut behind CDW10 Area C was complete and the block was detached from the parent rock (Figure 24). It was very gentle, with no slipping of the block, or any movement.

The block was slid out from beneath the overhang and the entire cradle rigged with webbing. After discussion about how to handle the block – the back is concave and there was a crack at the bottom – two dowels were drilled into the top edge of the rock using the core drill.

**Figure 24.** Area C from Site CDW10 has been cut out and is resting on a padded cradle.

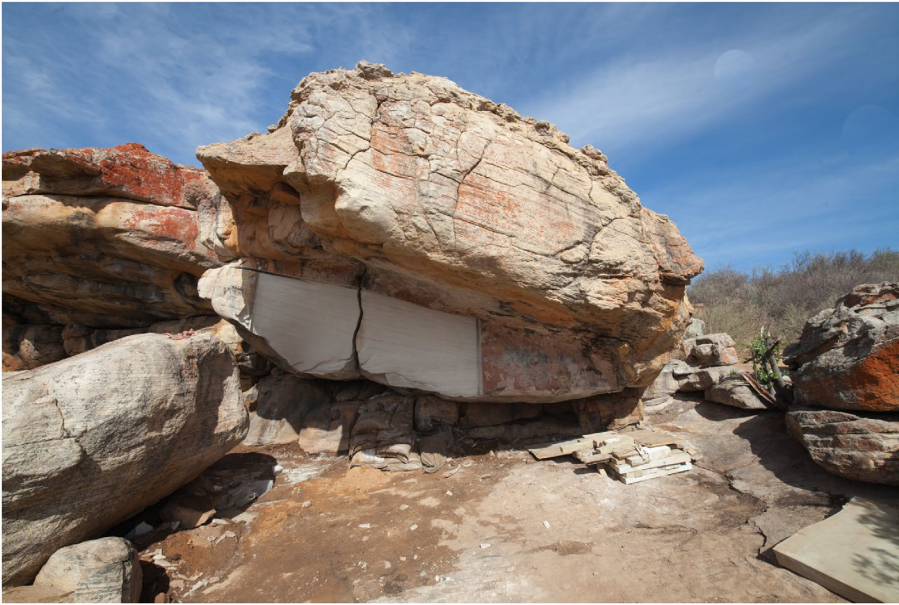
Work on cleaning off minor traces of slurry on the painted surfaces with distilled water and cotton wool poultices began immediately. This treatment was repeated where necessary over the next two days. The excess silicone beading was also rubbed off. A few small areas of silicone staining remain (especially on CDW10 Area B). A conservator could remove or disguise these stains.

**Figure 25.** Site CDW10 after the removal of the rock art.
